H083 MAINTENANCE NOTE NO. 2
(For Electronics Technicians)

2. Transmitter Box Door Seal Repair

H083 MAINTENANCE NOTE NO. 3
(For Electronics Technicians)3.0 H083 Maintenance Updates --Dewpoint Sensor Mirror Cleaning, Dewpoint Sensor
Factory Modification, and "O" Ring Inspections.GENERAL

6. H083 Sensor Optics Alignment

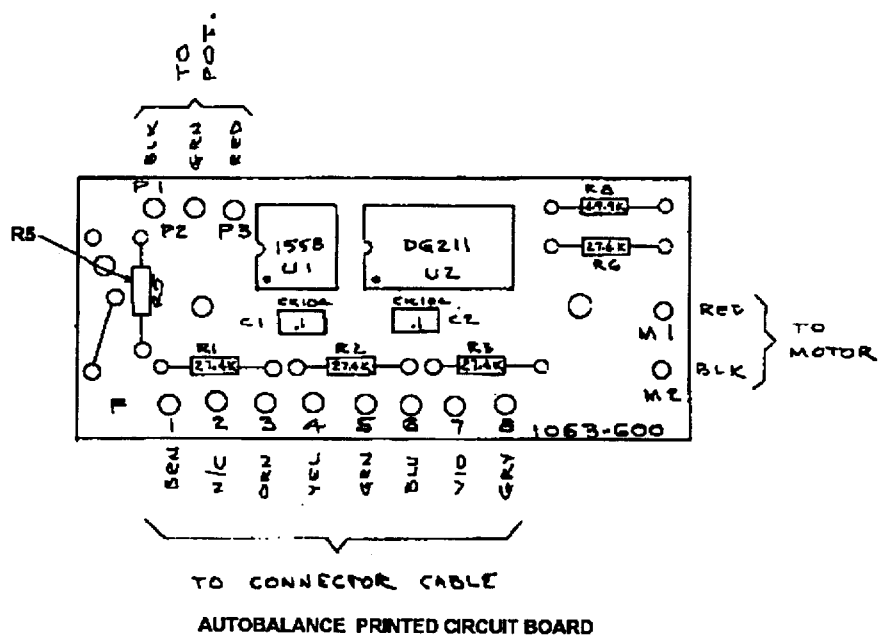
FIGURE 1

A. On the next trip to each site, inspect the R5 resistor for its value. Reference the autobalance printed circuit Figure 1 for location of R5 resistor.

- B. The resistor is marked with the resistance value. If marked with 249xx, the value is a 249K ohm resistor and is correct. If the resistor is positioned so that the resistance value is not visible, use a multi meter to decide the value. A resistance reading near 250K ohms is correct. A reading closer to 200K ohms is incorrect.
- C. If it is determined that the correct R5 resistor is installed, reinstall the autobalance.
- D. If it is determined that the incorrect R5 resistor is installed, return the autobalance module to NLSC and replace with the correct module.
- E. Inspect the spare's kit and return any autobalance modules found to NLSC. Most kits did not include the autobalance module.
- F. Order from NLSC per information in section 1C above. Documentation was changed to reflect the new logistics information.
